TechData Sheet

TDS-2025-SHR

Polymer Composite Utility Pipe Hangers

Highlights and Recommendations from NFESC Studies

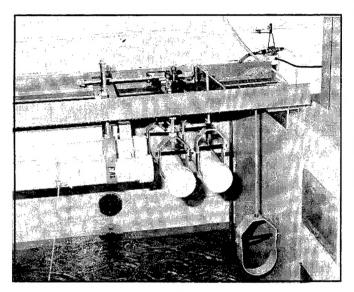
Figure 3. Tests on composite (yellow) and metal pipe hangers at NFESC seawater tank (environmental chamber).

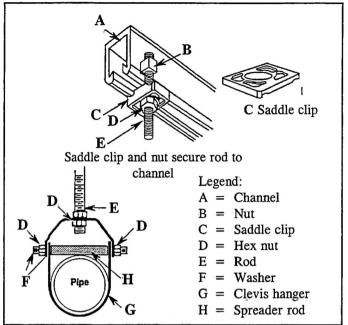
Figure 4. Pipe hangers.

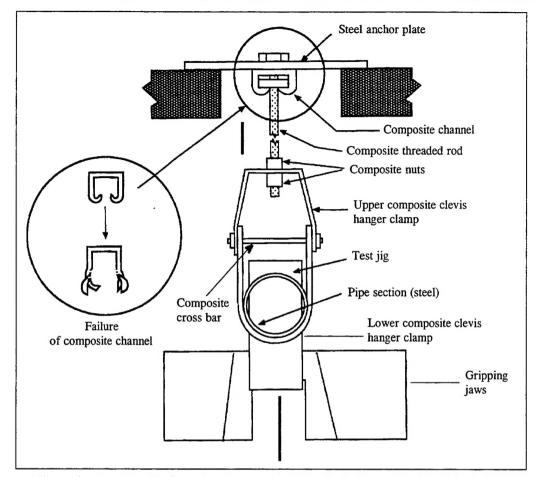
The results from Table 3 (and shown in Figure 9) are tensile tests for the entire hanger and channel system. The failure always occurred in the lips of the channel, which hold the rod and nut of the composite hangers, that is, the hangers did not break. However, it can be seen that the type of material used for the channel does matter when selecting the strongest system. According to the tensile test strength for Strut 1, which is a vinylester hanger, the channel strengths vary from Kynar®>polyester>polyvinyl chloride. The materials follow the same order for costs, that is Kynar® (\$80.00)> polyester (\$40.00)> polyvinyl chloride (\$26.00). The amount in parentheses is what we paid for each 10-foot length of channel.

Figure 9. Test assembly for polyester and vinylester clevis hangers (using a channel).

Although we did not perform long term weathering and tensile tests on the composite channel materials, it can be deduced from the present data that Kynar® is probably the strongest and most durable material, as well as the most expensive. PVC is the weakest and least durable, although the least expensive. Designers faced with balancing cost and durability may wish to consider using polyester channels, which are in the intermediate price and strength range.
